# **Mass Timber Demonstration Fire Test Project (MTDFTP)**

## **Literature Review**

**April 1, 2021**

CHM FIRE CONSULTANTS LTD  
103-858 Bank St.  
Ottawa, Ontario  
K1S 3W3

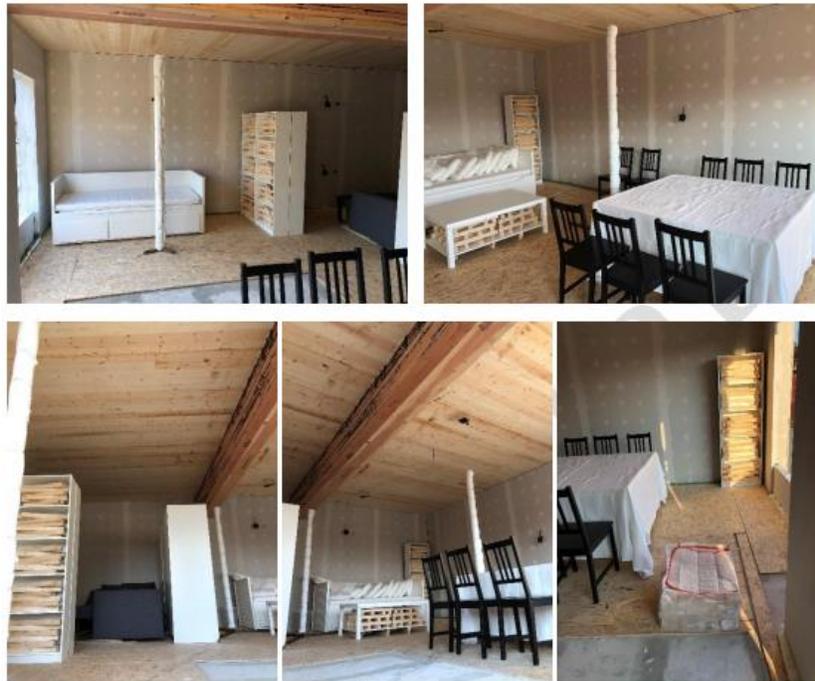
*Figure 9. Photos of the Furniture in Test 1 (Typical for Residential Tests) (Excerpt from [14]).*

The fuel load for the tests was a combination of typical apartment furniture, particle board sheets on the floor to represent a wood floor, and additional wood cribs representing fuel in storage spaces. The target fuel load density was 560 MJ/m<sup>2</sup>. Photos of a typical fuel setup are in Figure 9 below (excerpt from research summary report).
